RE: Site Inspection, Bedrock Stone Company, Bacon Rock Project, S/037/101, San Juan County, Utah

Date of Inspection: September 8, 2000  
Time of Inspection: 9:10 a.m. - 10:15 a.m.  
Conditions: Partly Cloudy, Warm  
Participants: Hector Cordova, mine crew; Tony Gallegos, DOGM

Purpose of Inspection: To examine the site while in the area and look at the waste rock slopes in response to request by the mine operator.

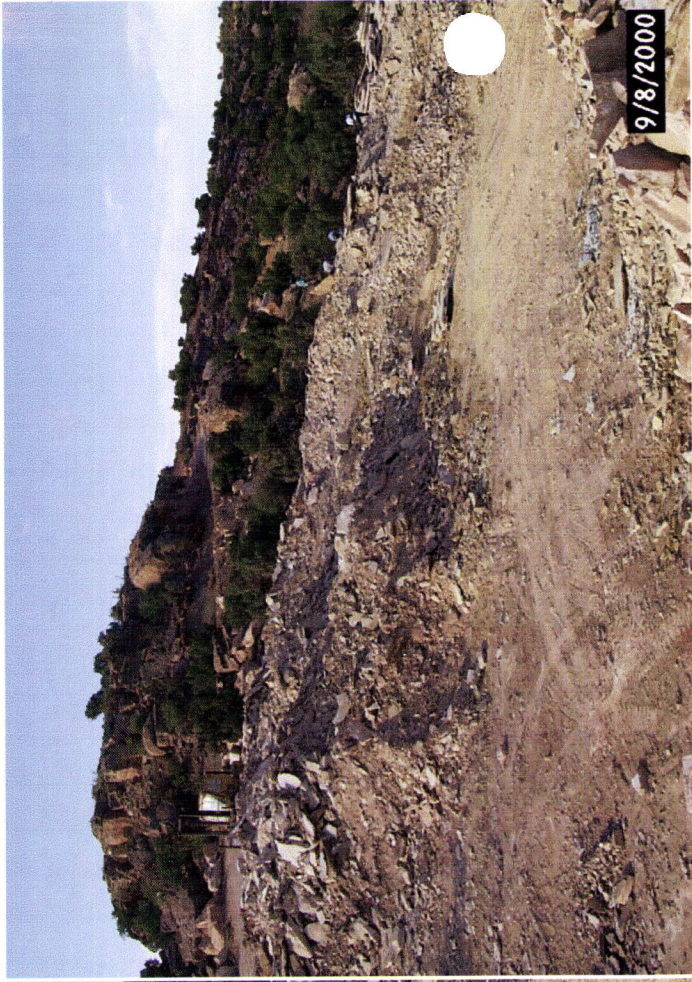
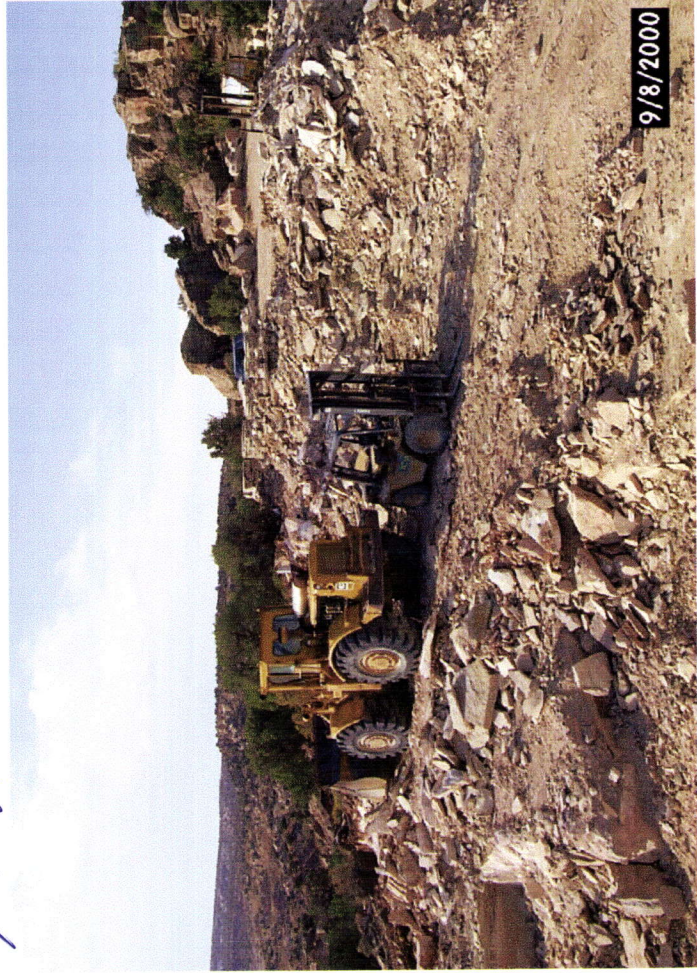
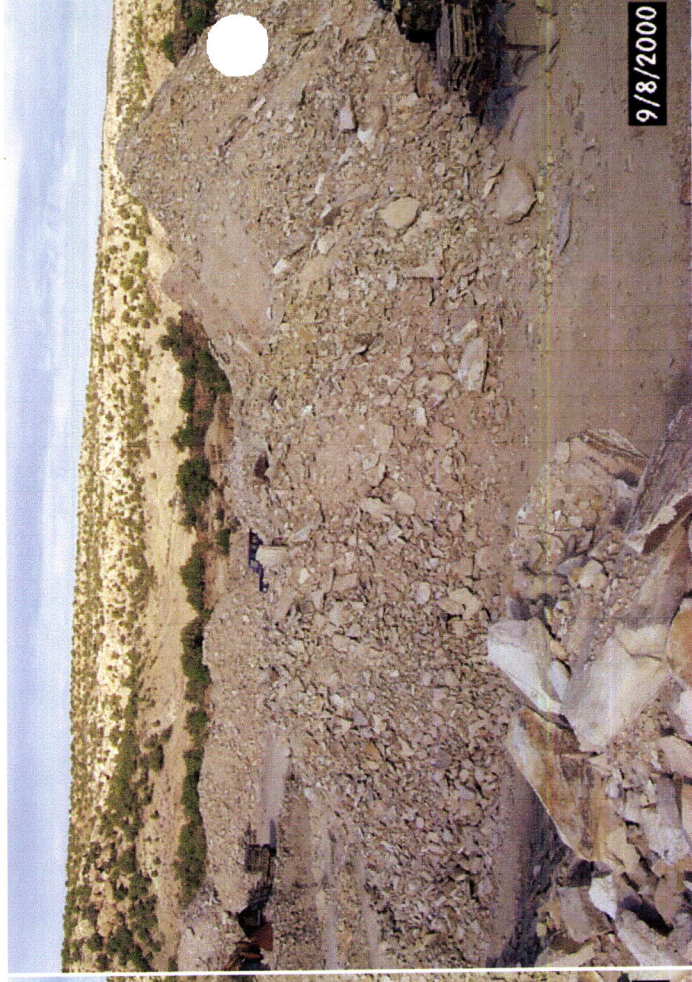
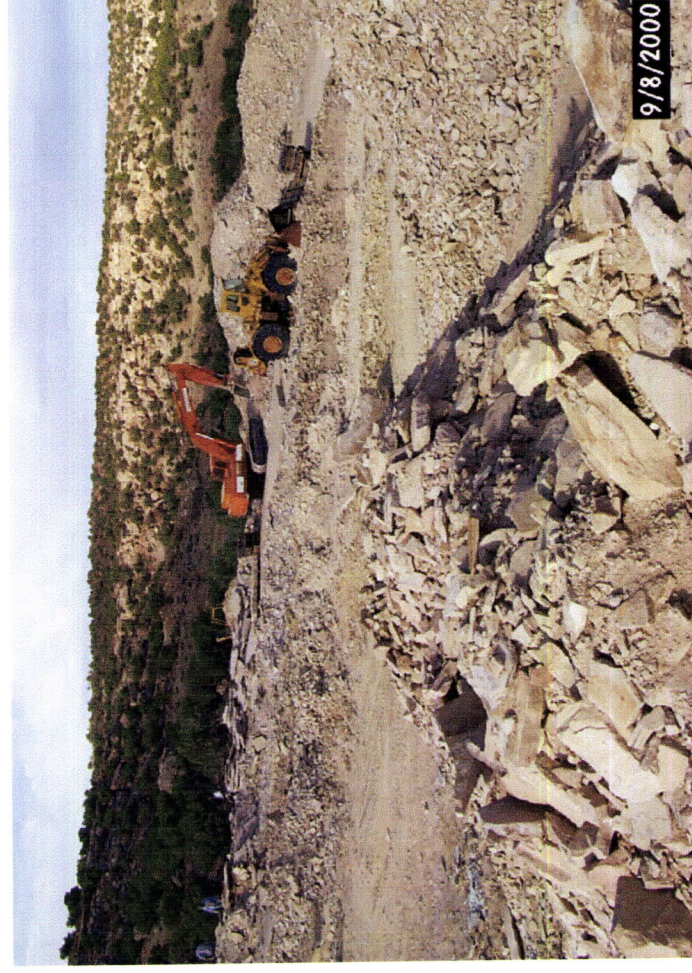
①

The site was active at the time of this inspection. Equipment and a number of workers were at the site actively splitting stone or other activities. I spoke with Hector Cordova who was one of the workers at the site who spoke English and Spanish. There are some old waste rock slopes on the north side of the site with the access road located down below. Photographs were taken of the mine site from a high point nearby. One photo shows the currently drilled portion of the rock quarry where the track excavator is located, with the other photos looking toward the south - southeast. Rock materials have been pulled back from the edge of the slope along the eastern edge of the quarry.

The waste dump slopes contain fines, but they are lighter in color than the surrounding soils. Placing fines from screening the rock piles would make the slopes the same color as they are now. Rather than placing additional soils on the dump slopes, it may be more useful to stockpile the fines for use as topsoil to be spread over the quarry at final reclamation. It would be best to avoid dumping additional waste down these slopes and broadcast seed these dump slopes as soon as possible.

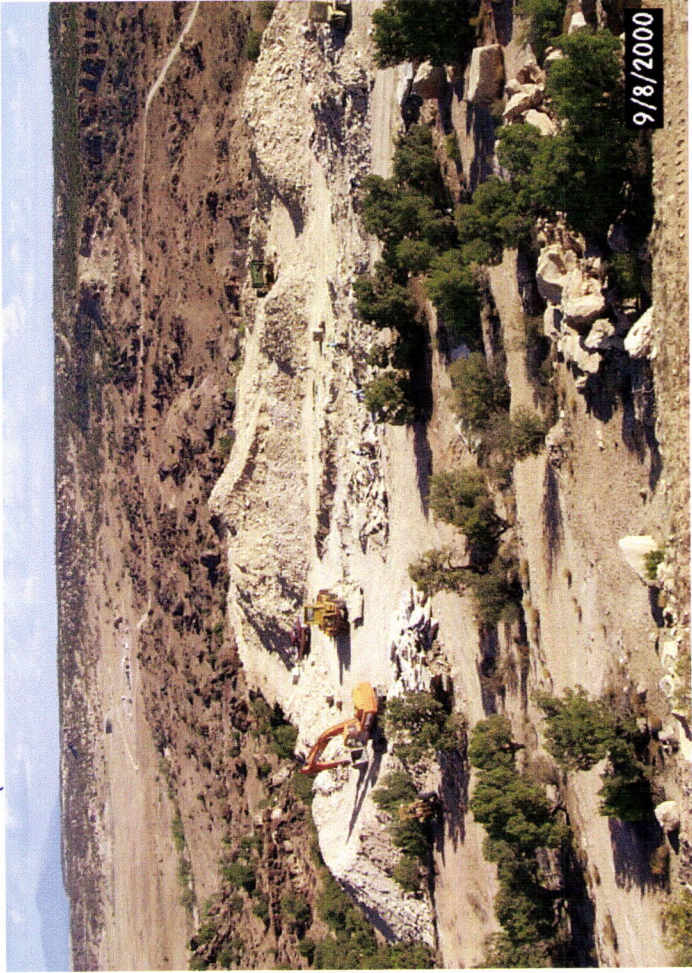
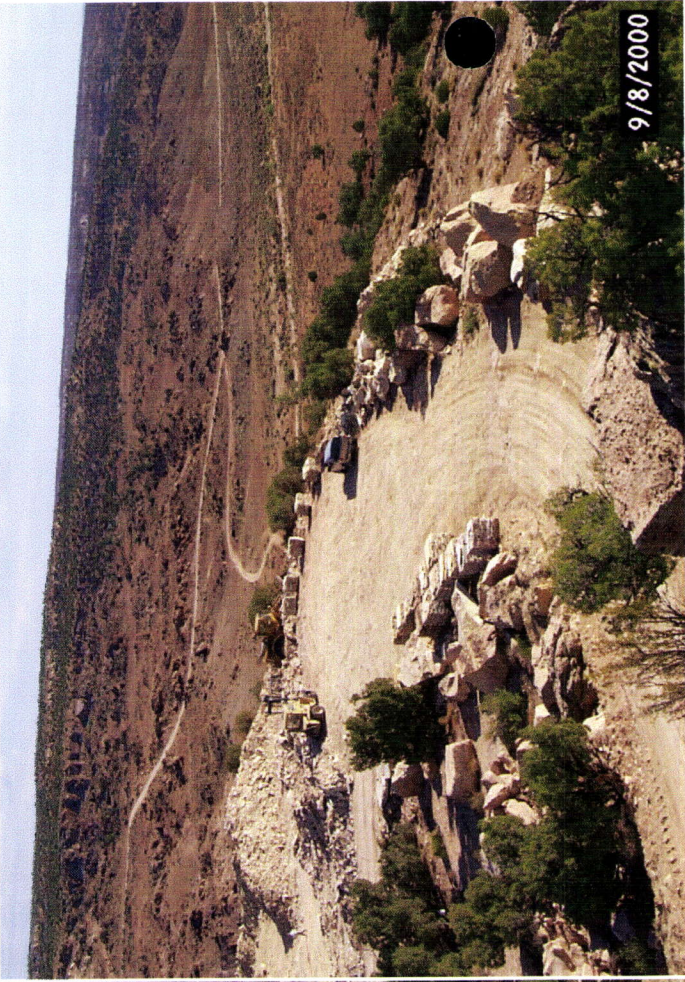
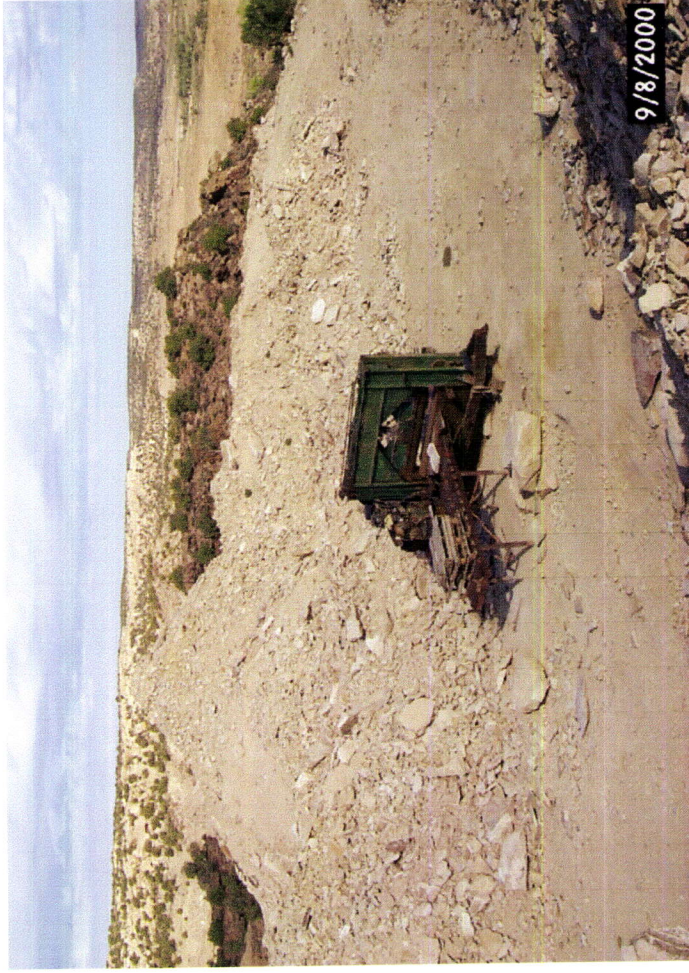
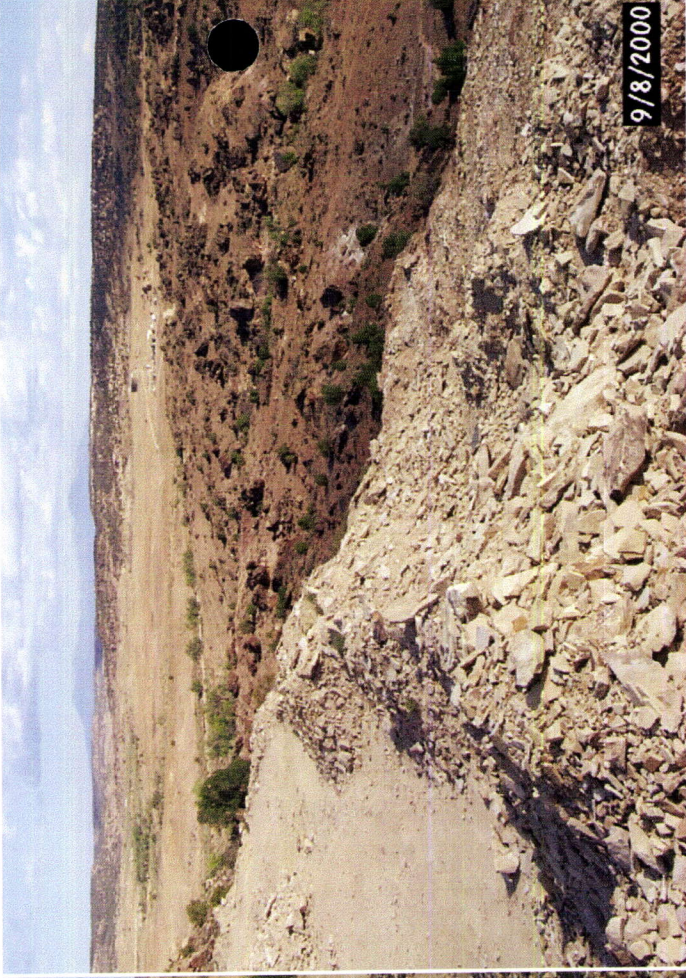
(2)

A visual estimate of the current quarry disturbance would be between 2 ½ - 3 acres. Additional photos were taken looking northeast to the northwest over the mine site from up on a rocky point to the southwest of the quarry. A field sketch of the general layout of the site was made from this vantage point.
